# ONTARIO Roofing NEWS

SPRING 2006

### project profile

# Nightmare On Yonge Street

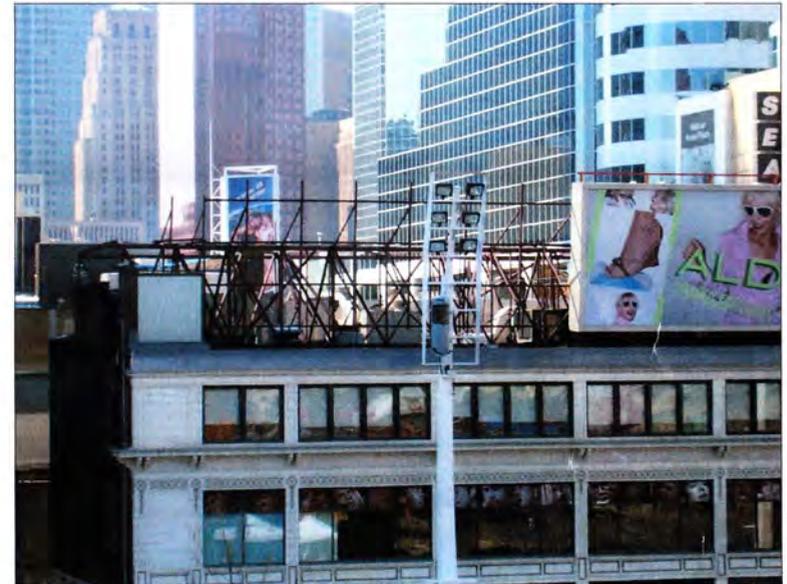
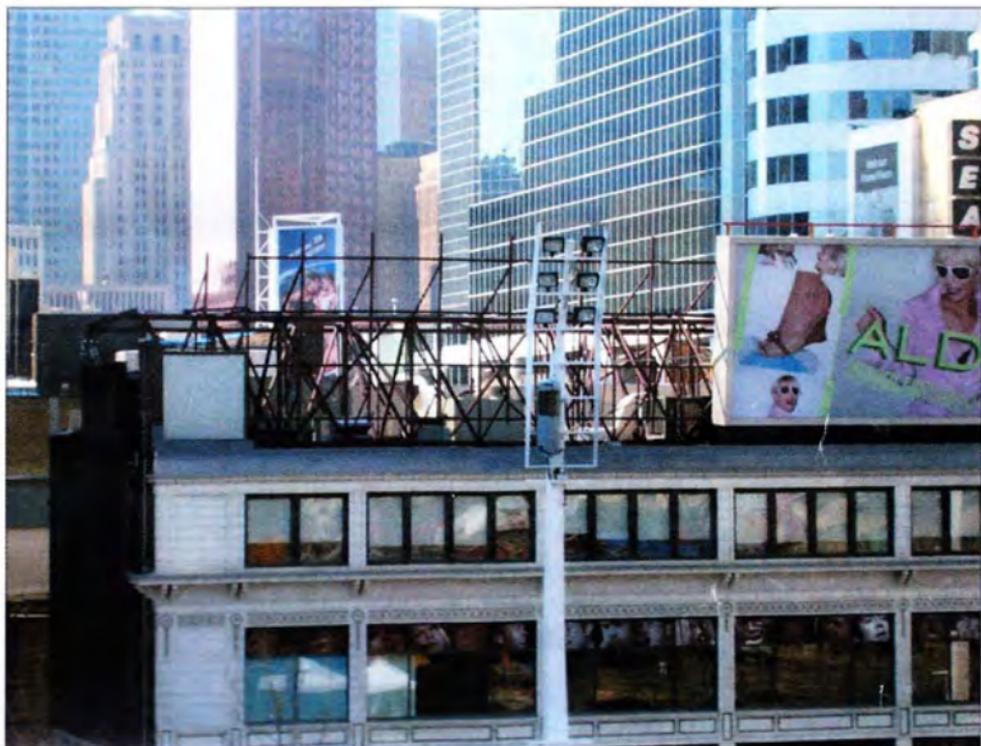
Well just take a look at the photos that accompany this article! There are many smaller buildings in this great metropolis we have come to call the GTA. The prospect of re-roofing many of these buildings can prove quite challenging for the roofing contractor.

Now getting back to those billboards, can you possibly believe that the maze of structural supports built over this roof are there

for the sole purpose of supporting those massive beacons of advertising? Clearly the roofing system on this building has not been

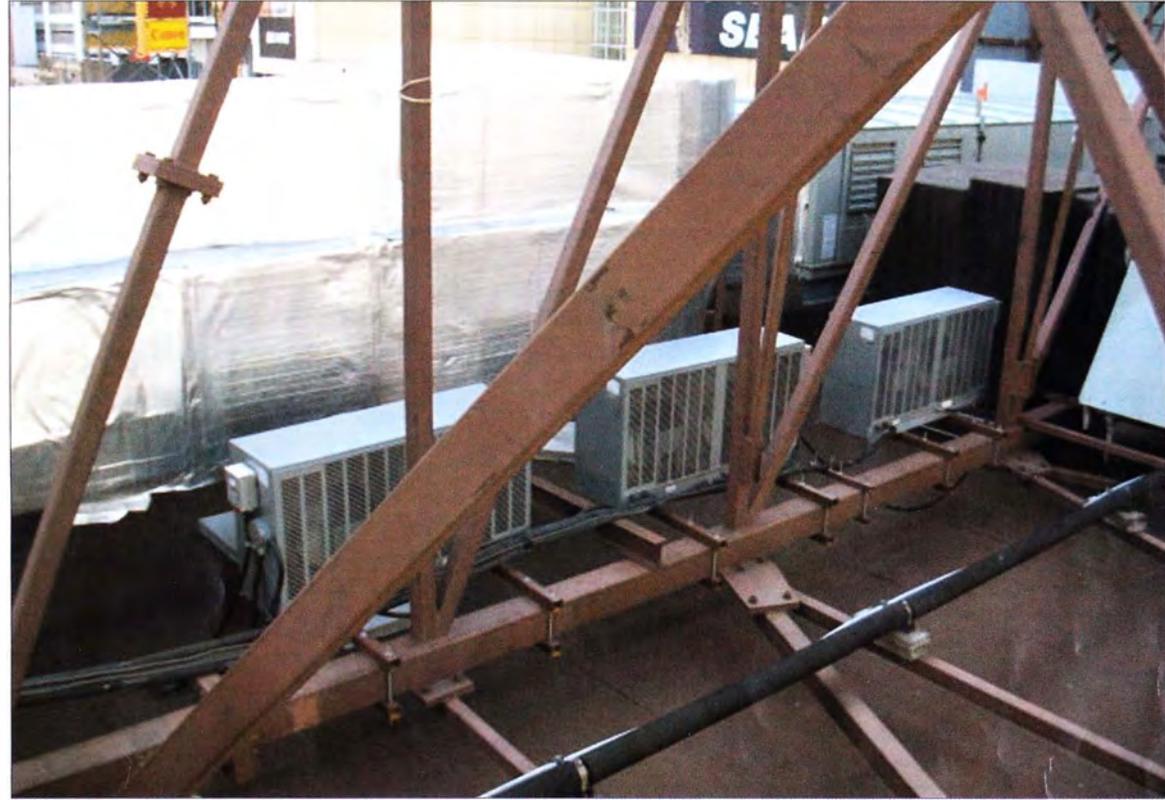
As you can see from the pictures, the roof has a number of HVAC units. These typically need to be raised so that their curbs may be flashed with membrane flashing and metal counter flashings. In an attempt to simplify this re-roofing process and any future re-roofing required, Dean-Chandler came up with the brainwave of lifting both small and large units up off their

curbs and resetting them onto the billboard steel structure. A structural

engineer first had to determine that the steel could structurally support the weight of the units. Along with the HVAC equipment, all gas lines had to be raised and connected to the steel structure as well.
